MORGRIP® ACHIEVES ANOTHER FULLY DIVERLESS CONNECTOR SUCCESS

CASE STUDY

MORGRIP® TEAMED WITH A MAJOR NORWEGIAN ENERGY COMPANY TO SUCCESSFULLY COMPLETE A COMPLEX DIVERLESS REPAIR TO A 30", 210BAR PIPE, 200M DOWN IN THE NORWEGIAN OIL AND GAS FIELDS.

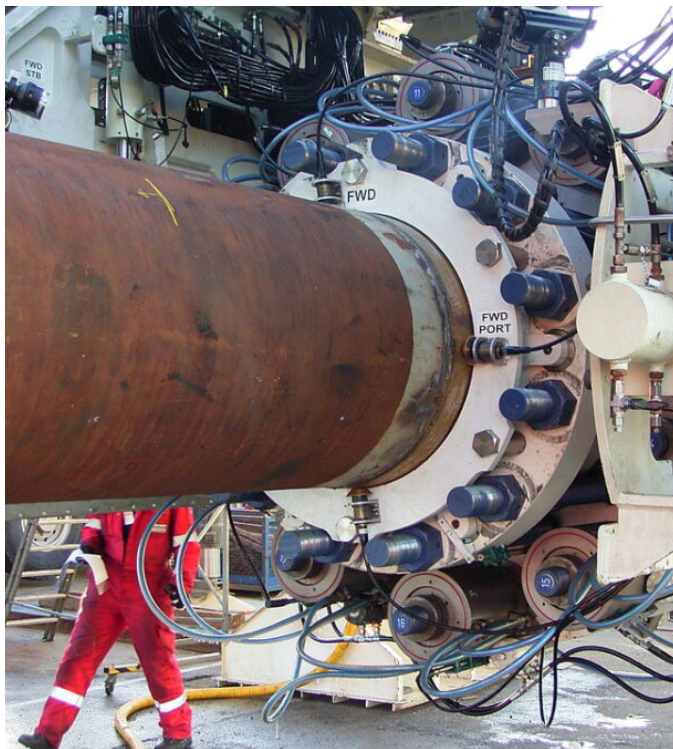
01 // MORGRIP® mechanical connector, ready for installation

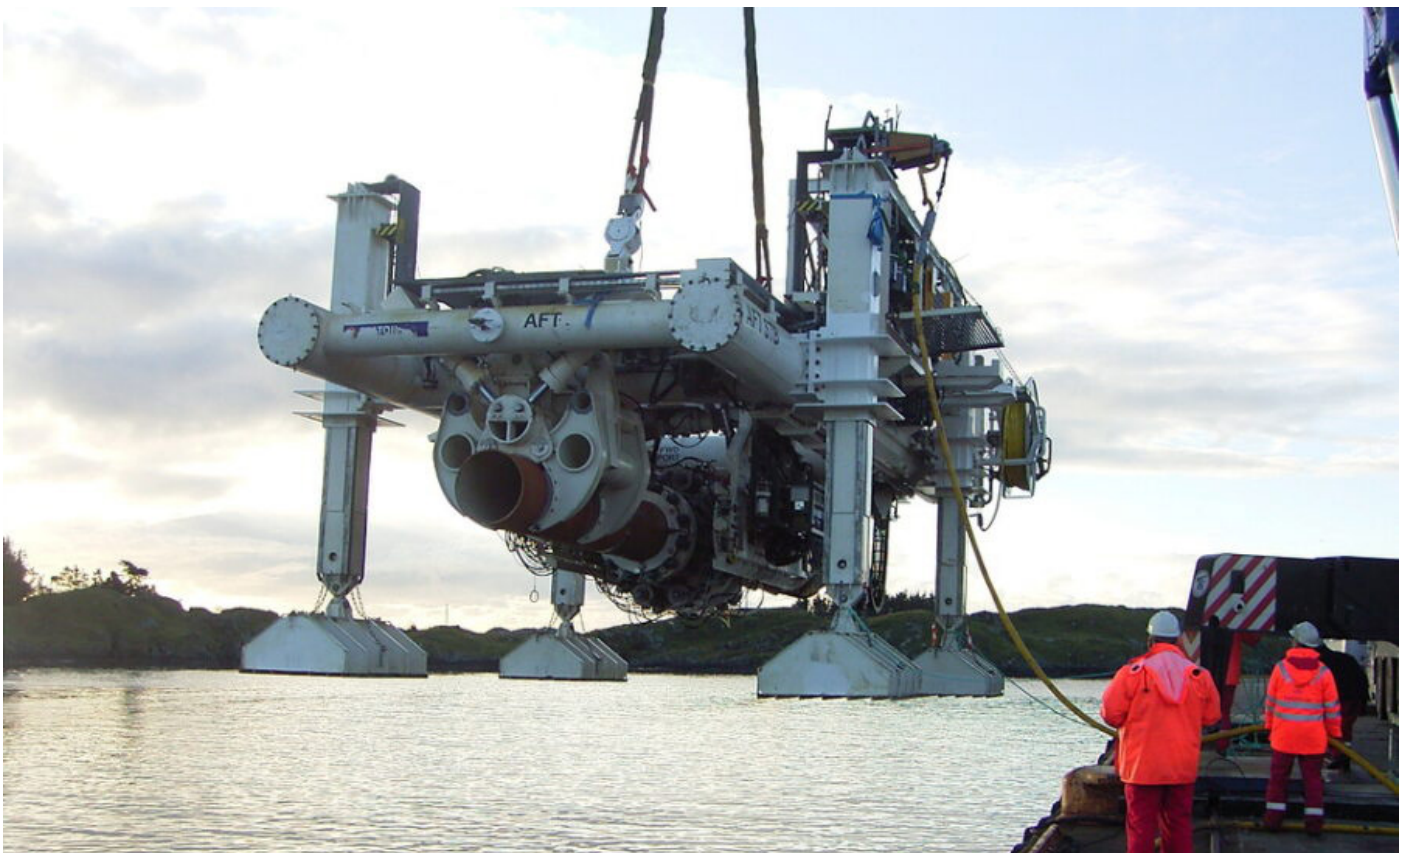
02 // The connector installation frame is lowered into the water

A separate Coupling Installation Frame (CIF), capable of ultra precise alignment movements, was lowered to the sea bed holding a new 25m section of pipe with a connector on the end. The two pipe ends were carefully aligned inside the connector and hydraulically energised.

The CIF was repositioned on the other end of the insert pipe and the procedure repeated to complete the repair. External pressure testing facilities within the connector ensured that the installation could be fully tested prior to any further pipeline operations or testing.
