MORGRIP® OVERCOMES PIPELINE CLEARANCE CHALLENGES WITH BESPOKE END-CONNECTOR SOLUTION

CASE STUDY

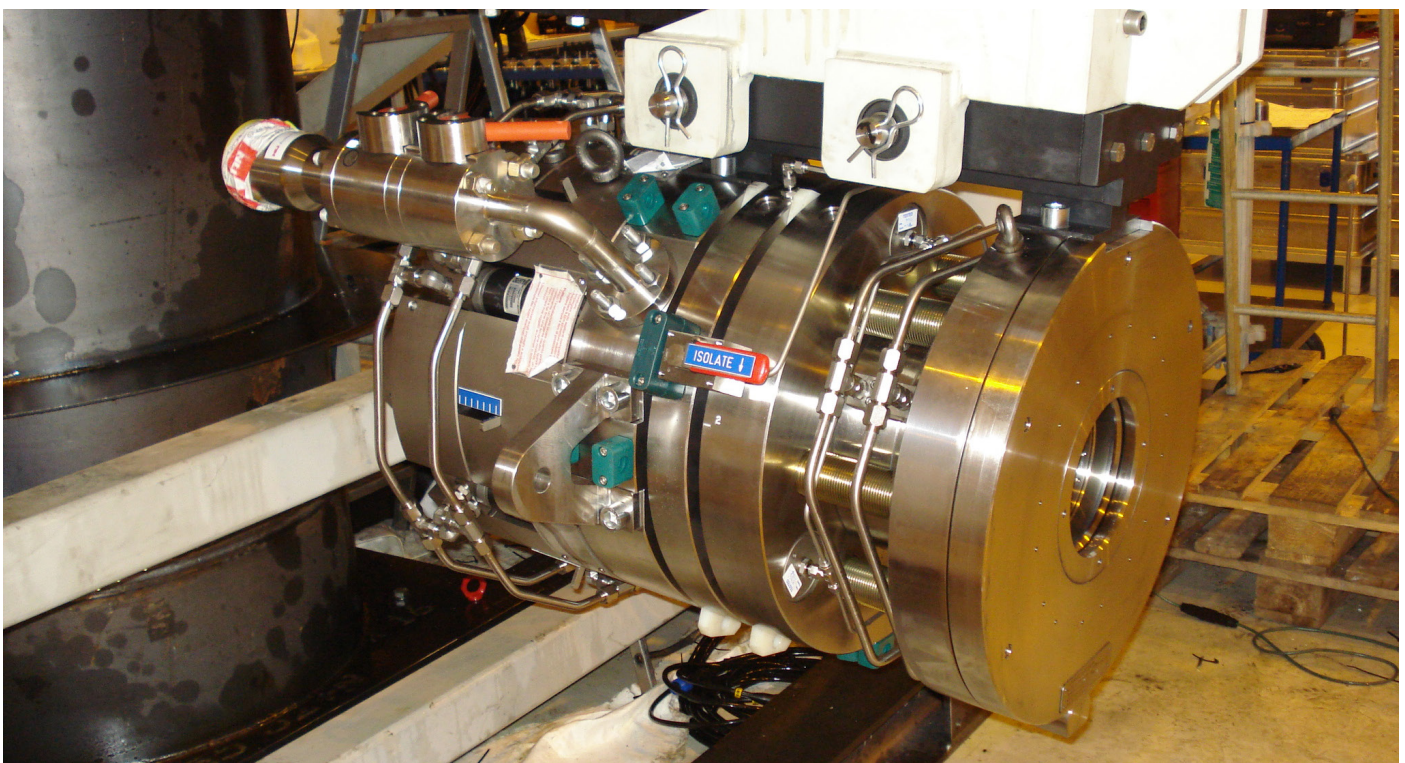
A mandrel and its 6" supporting pipe had been pulled out of position during an operation, overloading the pipe and forcing the shutdown of an associated 10" line, halting production.

01 // MORGRIP® engineers created a special end-connector to handle a difficult repair

The cracked pipe was partially inside the manifold, so MORGRIP® engineers had to ensure the connector’s overall dimensions were an absolute minimum, so it would fit in the available space.

A 6” super duplex end-connector had to be specially engineered to fit within the significant physical constraints of the damaged manifold.

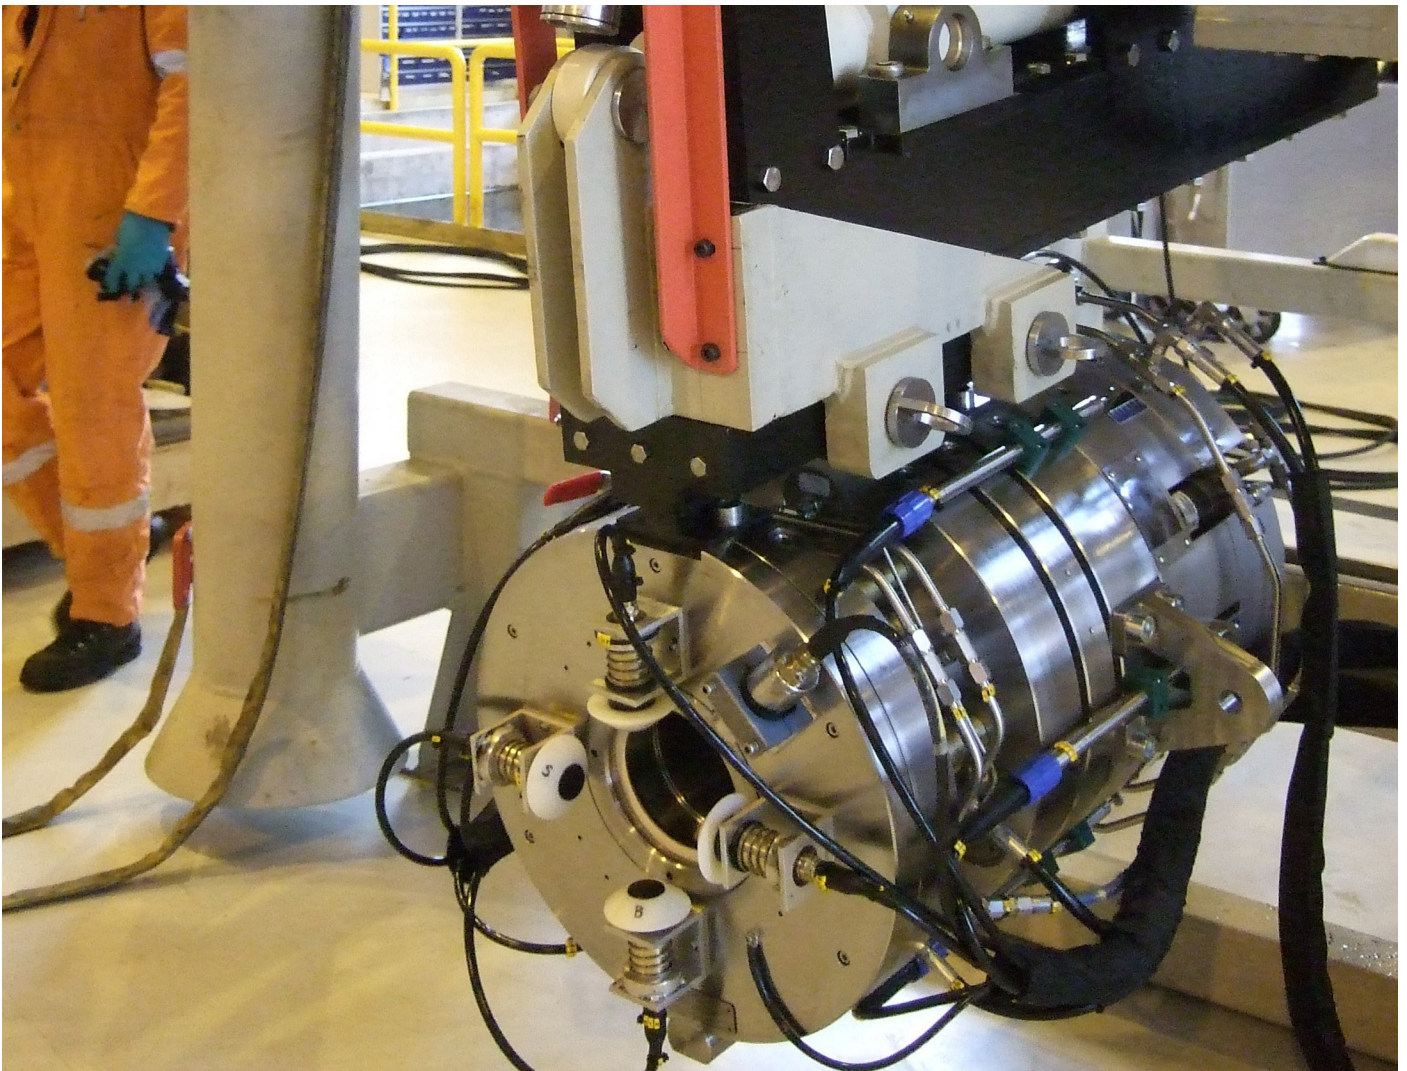
02 // MORGRIP® end-connector testing

The pipe, which carries a mixture of water, oil and gas, was pressure tested to 267bar after the procedure, and was tested again at regular intervals to make sure there has been no further pipe deterioration.
