# NEW APPROACH TO DELIVERING LIGHTWEIGHT HIGH-PRESSURE REMOTE CLAMPS

## CASE STUDY

A MAJOR OPERATOR IN WESTERN AUSTRALIA EXPERIENCED A DEEPWATER PIPELINE FRACTURE WHICH REQUIRED AN URGENT REPAIR. THE OPERATOR COMMISSIONED CONNECTOR SUBSEA SOLUTIONS (CSS) TO DEVELOP A NEW CLAMP SOLUTION TO MEET THE SPECIFIC DEMANDS OF THE PROJECT.

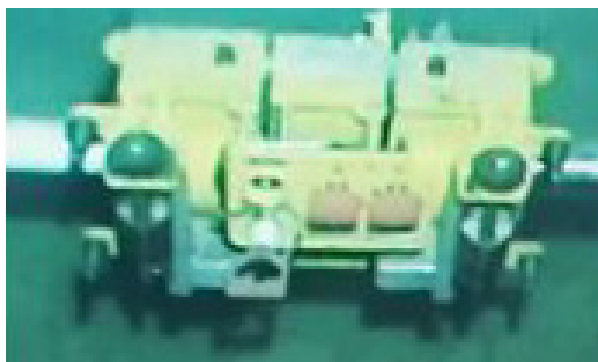
05 // CSS MORGRIP® 4" C-Bar Remote Clamp repair complete

The coating removal operation was conducted first, providing a bare pipe onto which the clamp would seal. The clamp mounted in the installation frame was then deployed. Lowered directly onto the repair location, the frame supported the weight of the system during activation and testing. Upon completion, the frame disconnected and was retrieved to the vessel, leaving only the clamp as a permanent repair on the pipe.

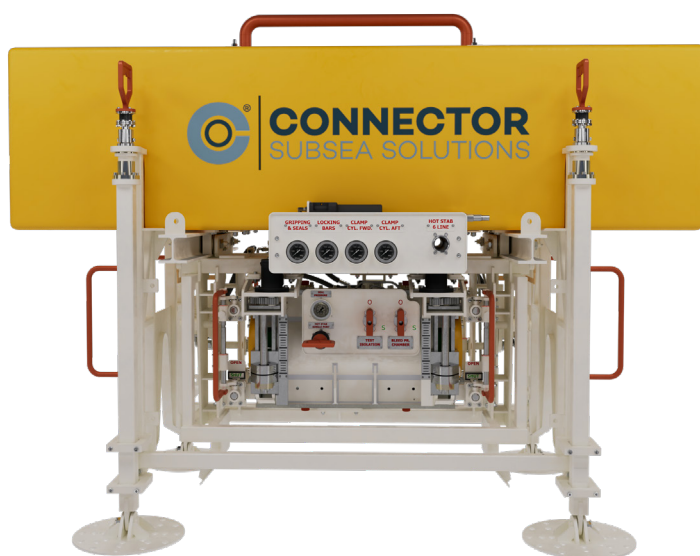
07 // CSS MORGRIP® C-Bar Remote Clamp

CSS had recently delivered the new C-Bar System. This activation method mitigates the need for multiple tensioner units and controls the activation from a single location, ideal for enabling separation of function.
