# RAPID RESPONSE TO DELIVER CLEAN COATING REMOVAL AT 1 000 MWD

## CASE STUDY

CALLED IN AT SHORT NOTICE AFTER ANOTHER TOOL FAILED ONSHORE TRIALS, CONNECTOR SUBSEA SOLUTIONS (CSS) MOBILISED ITS PATENTED DEEPWATER COATING REMOVAL TOOL (CRT), ROV SKID, CONTROL SYSTEM AND OFFSHORE PERSONNEL TO DELIVER CLEAN, DAMAGE-FREE COATING REMOVAL ON A 12" PIPELINE IN APPROXIMATELY 1 000 MWD. THIS RAPID RESPONSE, AIRFREIGHT MOBILISATION AND THE BARE-METAL FINISH WERE CRITICAL TO KEEPING DECOMMISSIONING WORK ON TRACK.

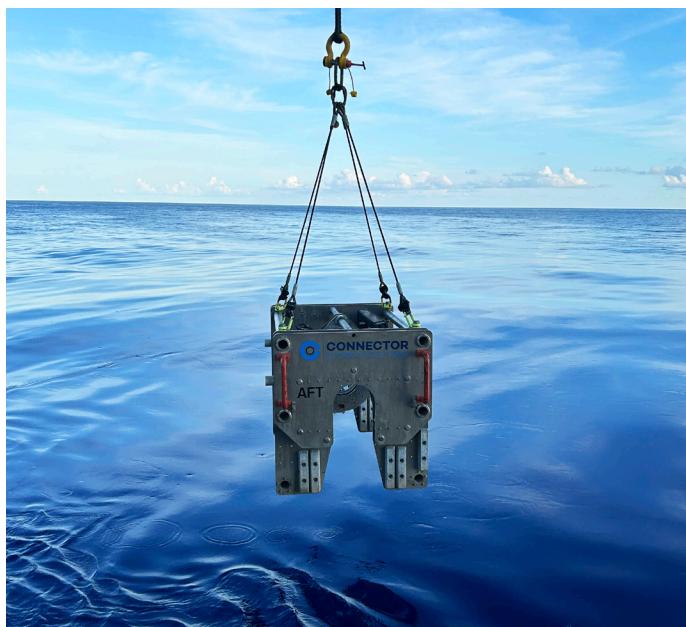
01 // CSS Deepwater CRT offshore deployment.

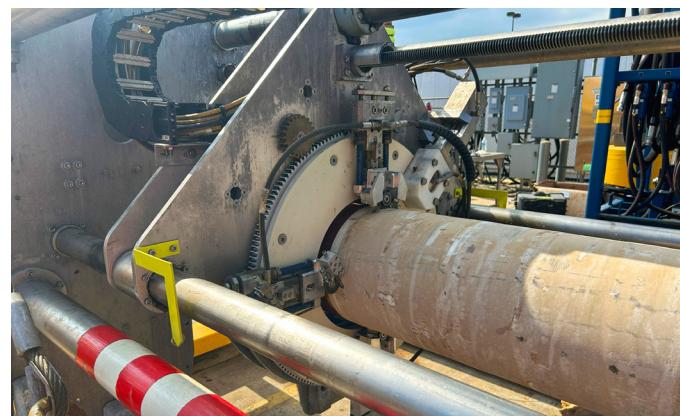
02 // CSS Deepwater CRT preparing for onshore System Integration Test (SIT).

- Enquiry to dispatch:** 7 working days
- System Integration Test (SIT):** Completed in 1 day
- Coating removal time:** ~12 hours per location (clean, damage-free finish)

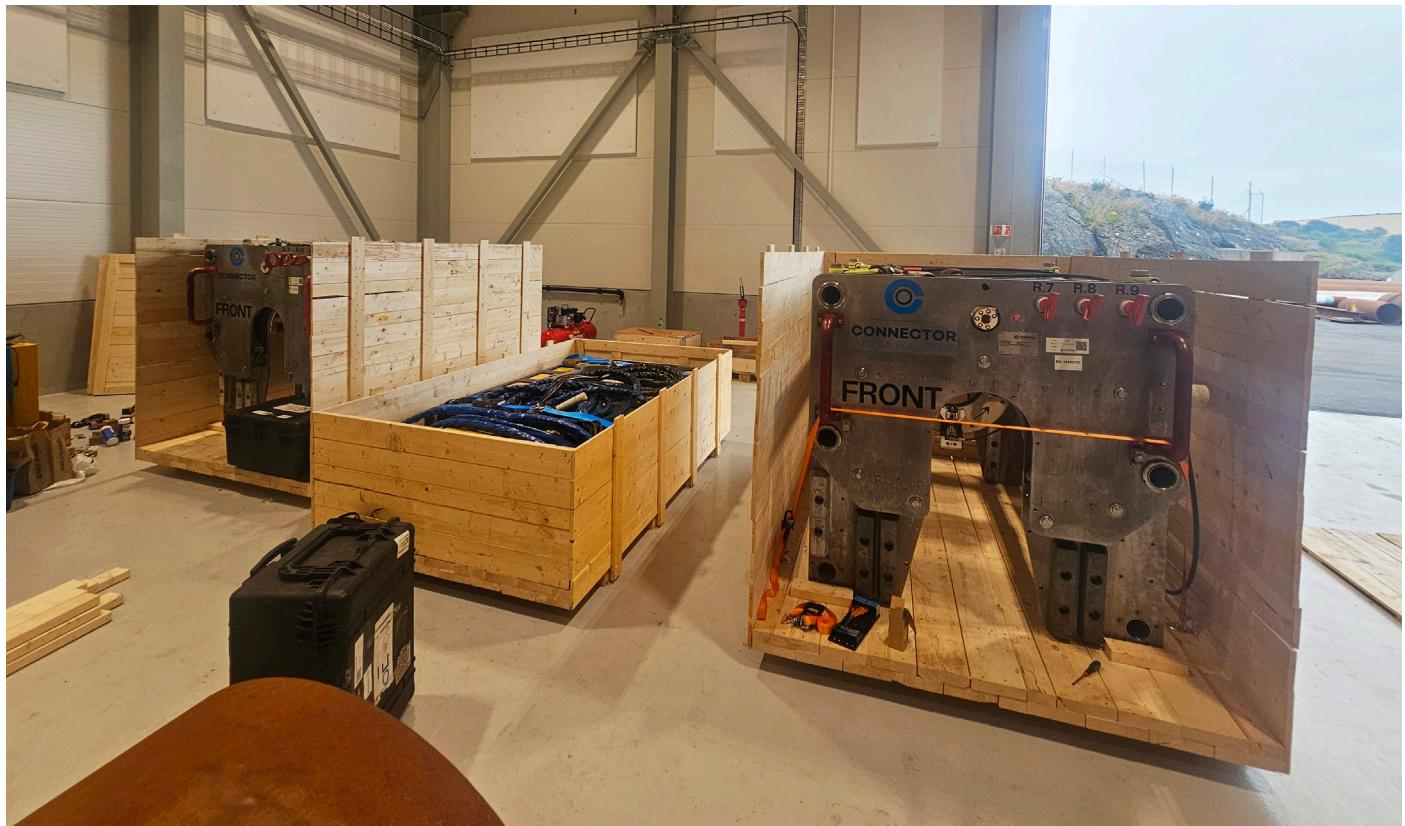
03 // CSS Deepwater CRT and ROV Skid packed and ready for offshore deployment.

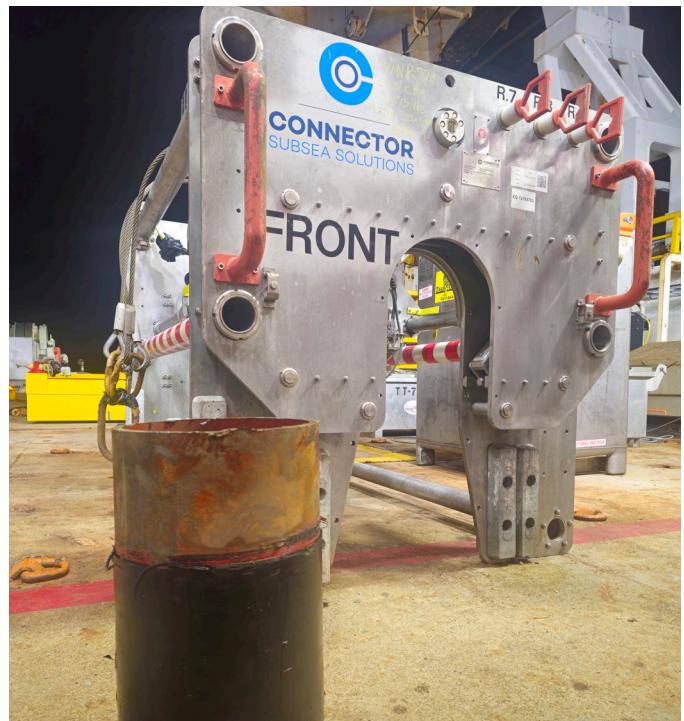
04 // CSS Deepwater CRT with a retrieved pipe section after coating removal.

Both locations were stripped back to clean, bare pipe with no damage to the parent pipe. The job met the schedule despite airfreight delays, enabling the operator's downstream activities to proceed. The CRT operated reliably at depth and the finish met the acceptance criteria.

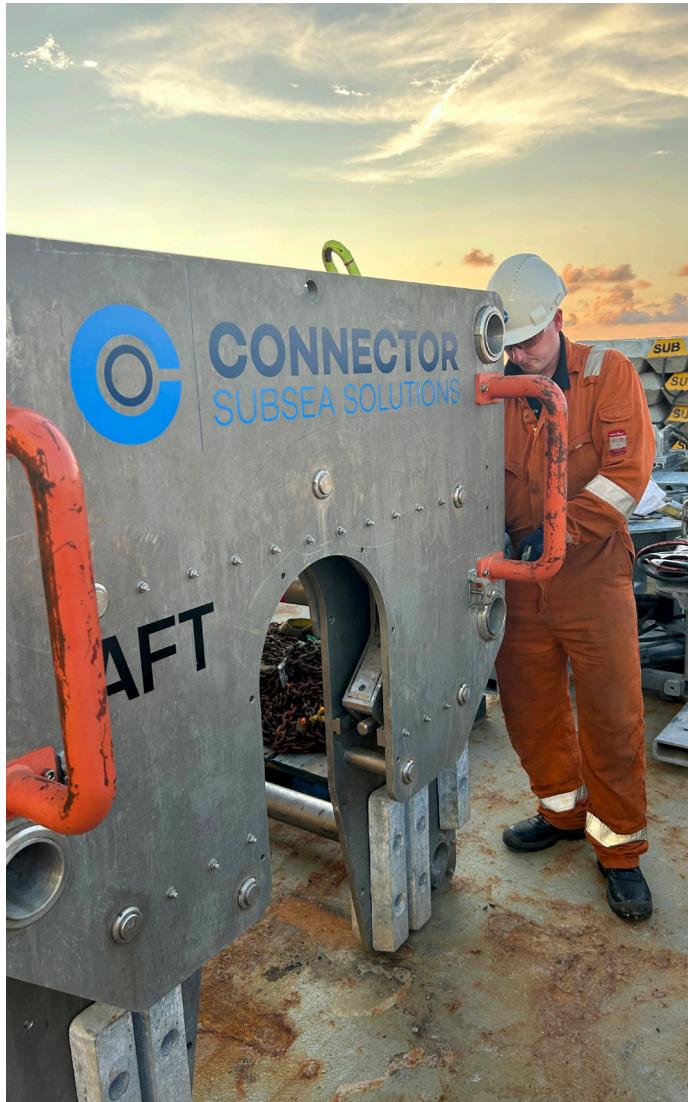
05 // CSS Deepwater CRT checked by CSS field service technician prior to offshore deployment.

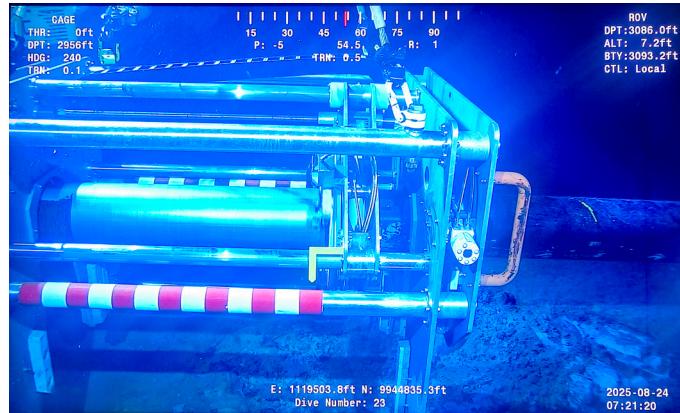
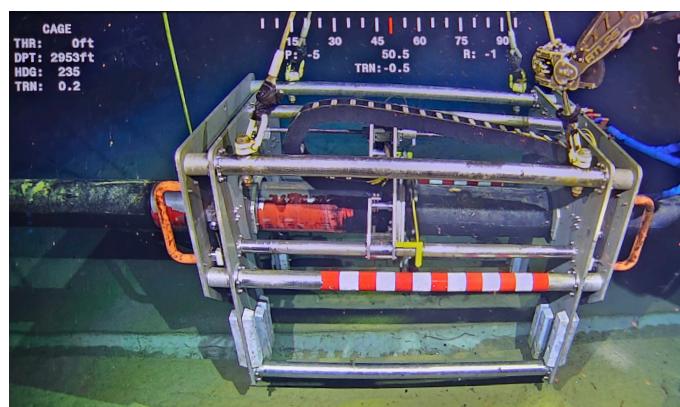
06 // CSS Deepwater CRT during offshore operation.
