# FLEXIBILITY AND HOLISTIC SERVICE ENSURE SUCCESS IN WEST AFRICA PIPELINE REPAIR

## CASE STUDY

THE MORGRIP® TEAM PROVIDED AN EFFECTIVE AND EFFICIENT SOLUTION UTILISING A 12" CONNECTOR, ALONG WITH TRAINING AND INSTALLATION ON A WEST AFRICAN PLATFORM.

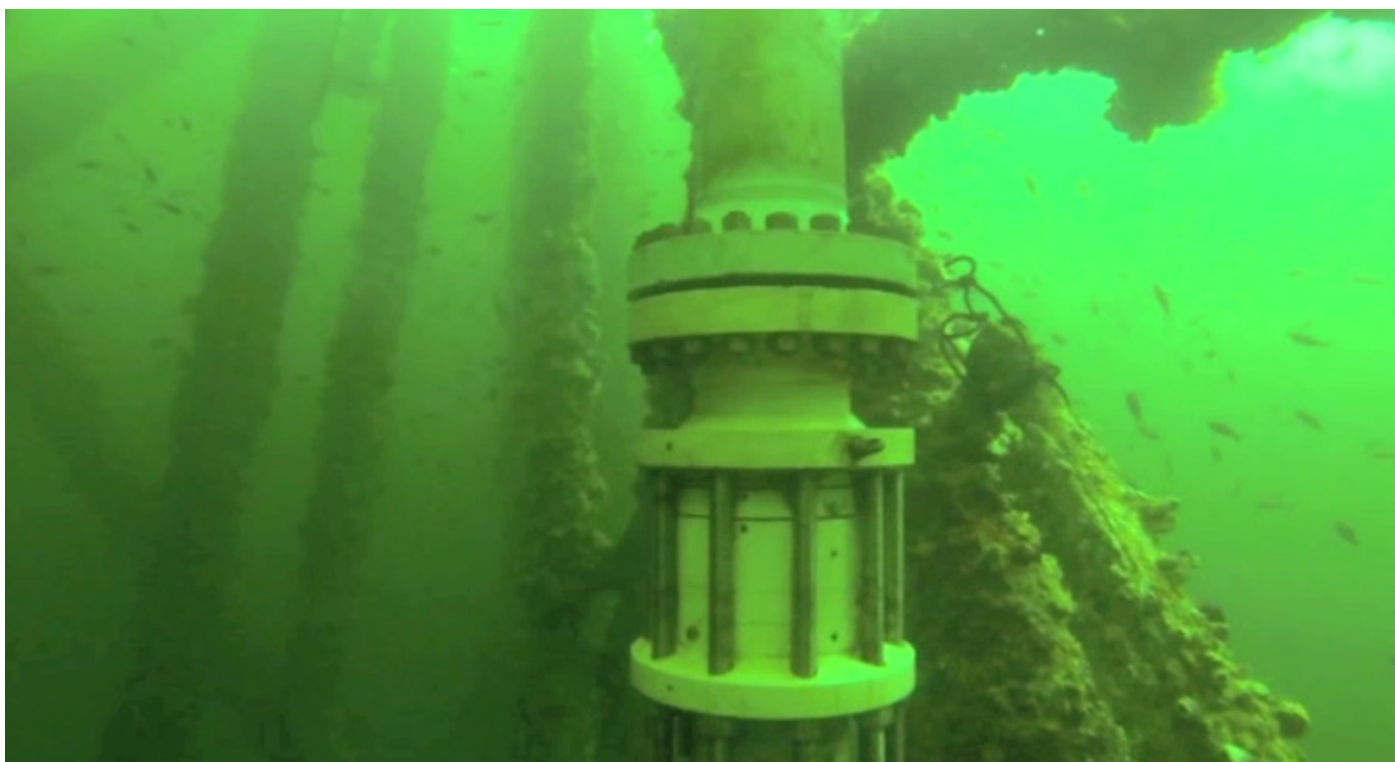
02 // MORGRIP® connector installed subsea onto vertical riser.

MORGRIP® coordinated with the dive crew ahead of the job, providing full onshore training on all three pieces of equipment. During the installation campaign, the export line was cut above the topside field joint and the connector was installed subsea. The project was completed within a short 14-week timeframe,
